ULTRASONIC PLY-BY-PLY DETECTION OF MATRIX CRACKS IN
LAMINATED COMPOSITES

A Thesis

Major Subject: Aerospace Engineering

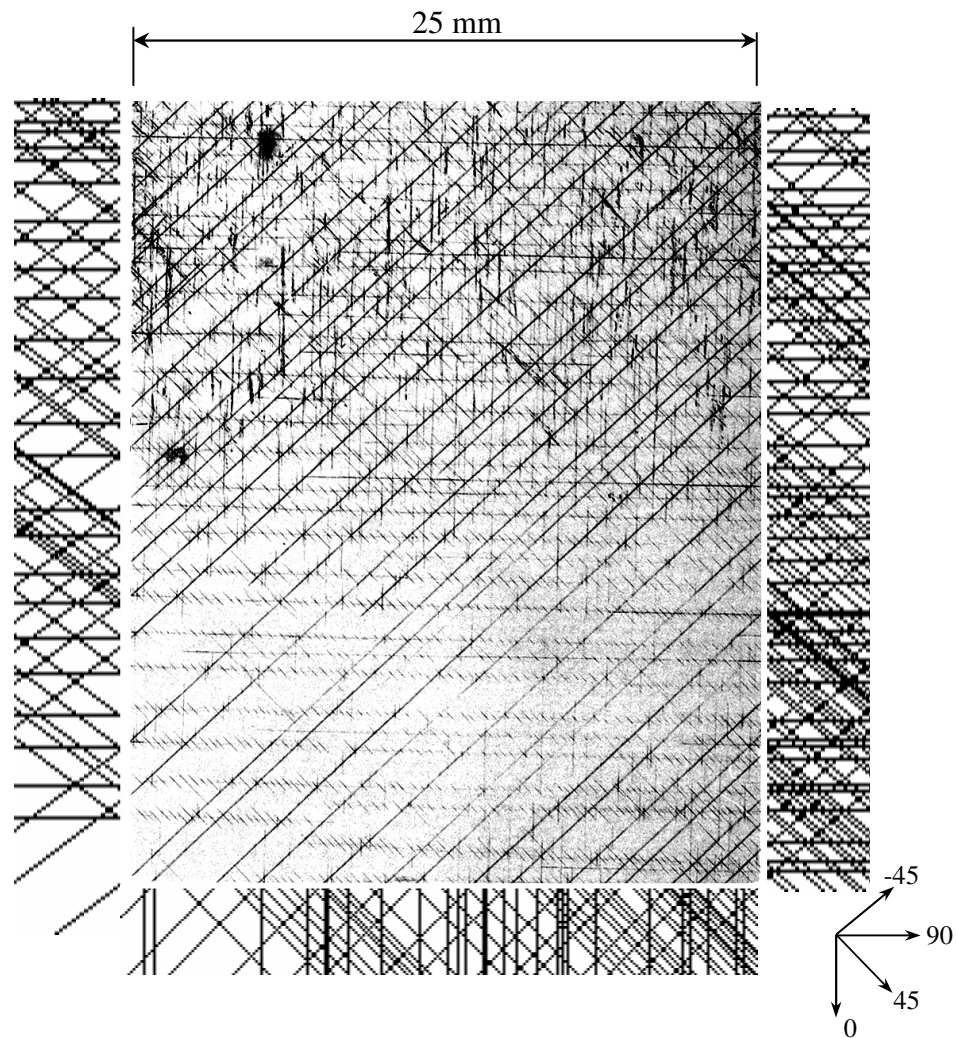
Fig. 2.29 A comparison of a part of the X-ray image of the TAMU-2 laminate with the schematic of the optically detected matrix cracks at the edges.

A similar exercise was also conducted for all the other specimens. A comparison of the X-ray image and the schematic of the optically detected cracks for the TAMU-2 and the TAMU-3 specimens are presented in Figs. 2.29 and 2.30 respectively. For the clarity of communication, for each of these specimens, only small areas at one of the ends were chosen for comparison. A good correlation between the results obtained by the two methods is observed for the cracks running in the 90° and the -45° direction. As in the case of TAMU-1 specimen, in these specimens too a large number of cracks in the 45° and the 90° plies were detected using optical microscopy. Again, the correlation between the X-ray image and the schematic of the optically detected edge cracks for the 0° and the 45° plies for both these specimens is not clear due to the presence of short cracks. Fig. 2.31 shows the comparison between the X-ray image and the schematic of the optically detected cracks in a small area of the TAMU-4 specimen. The area shown in Fig. 2.31 does not include either end of the specimen, due to which, the examination of 0° plies was not possible. Hence, the cracks in the 0° plies are not included in the schematic. Only two cracks running in the 45° direction (see top left corner of the schematic) were observable at the edges. A good correlation is observed between the

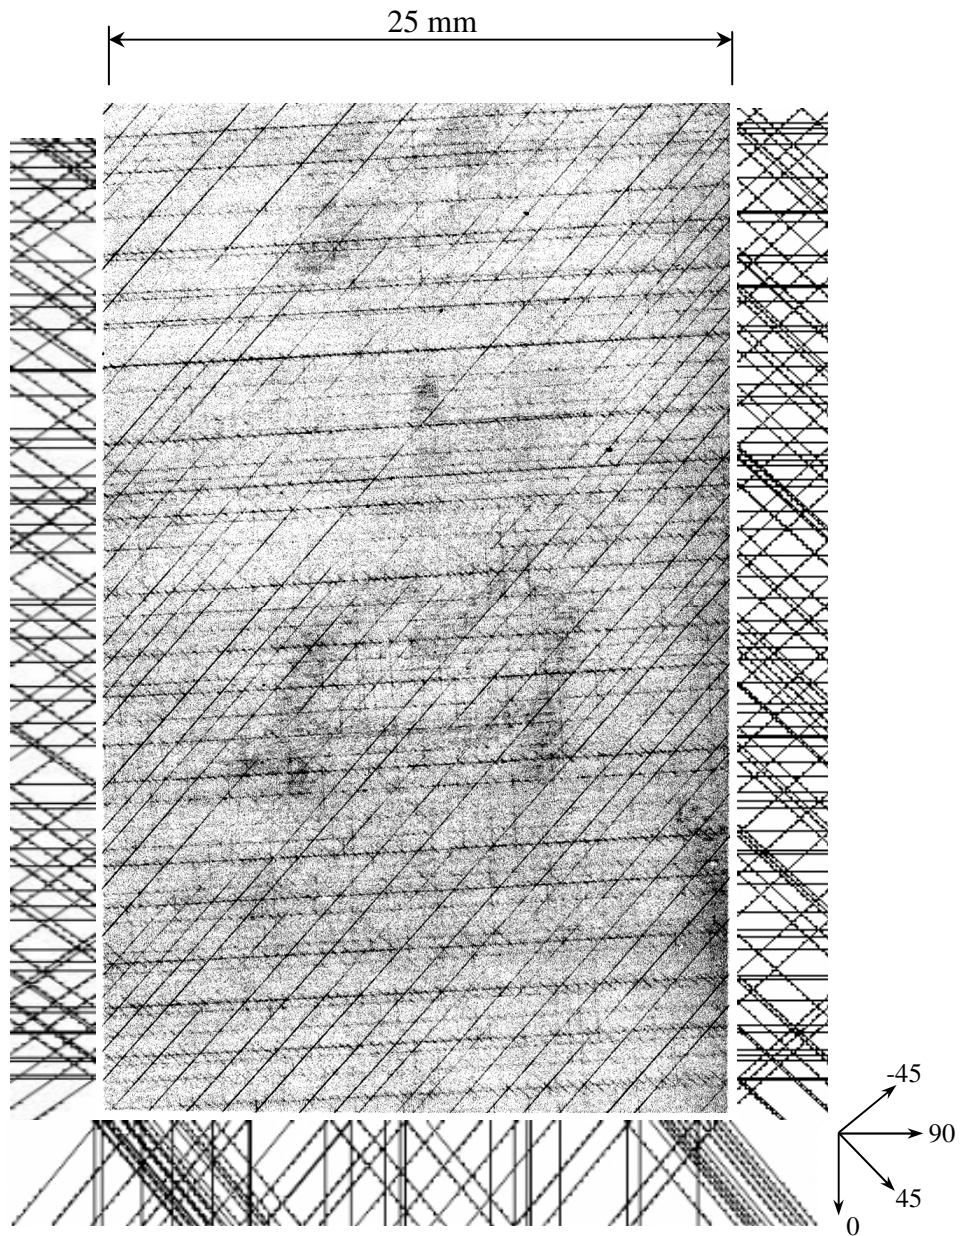
Fig. 2.30 A comparison of a part of the X-ray image of the TAMU-3 laminate with the schematic of the optically detected matrix cracks at the edges.

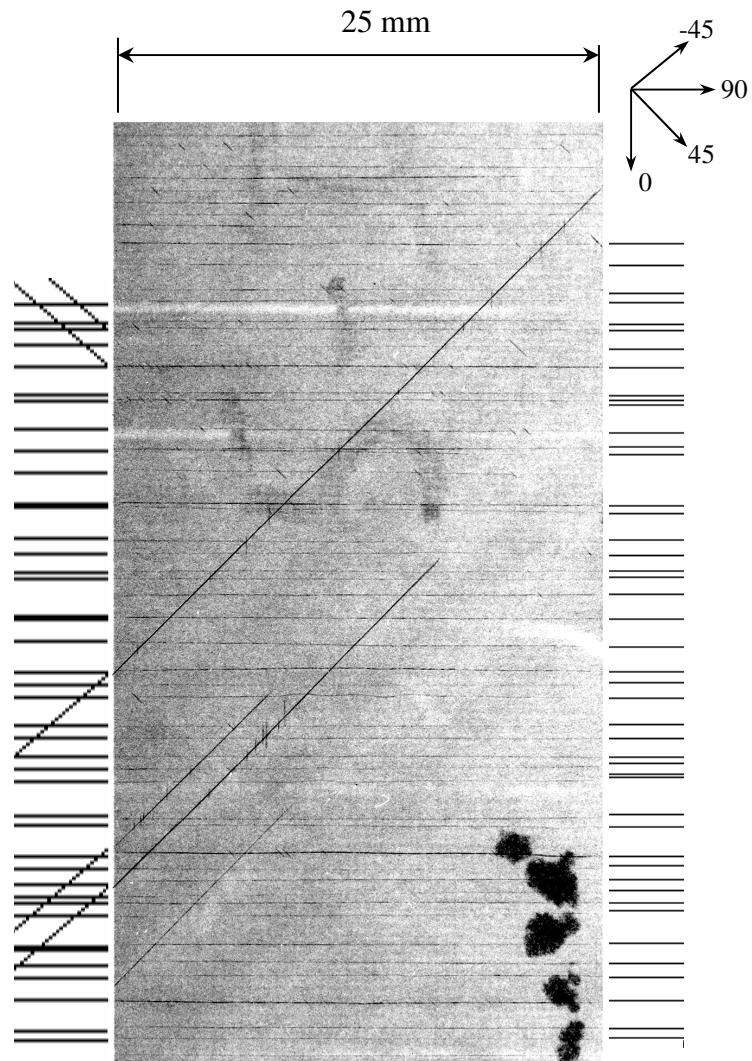
Fig. 2.31 A comparison of a part of the X-ray image of the TAMU-4 laminate with the schematic of the optically detected matrix cracks at the edges.

X-ray image and the schematic of the optically detected cracks for the cracks in the 90° and the -45° plies.

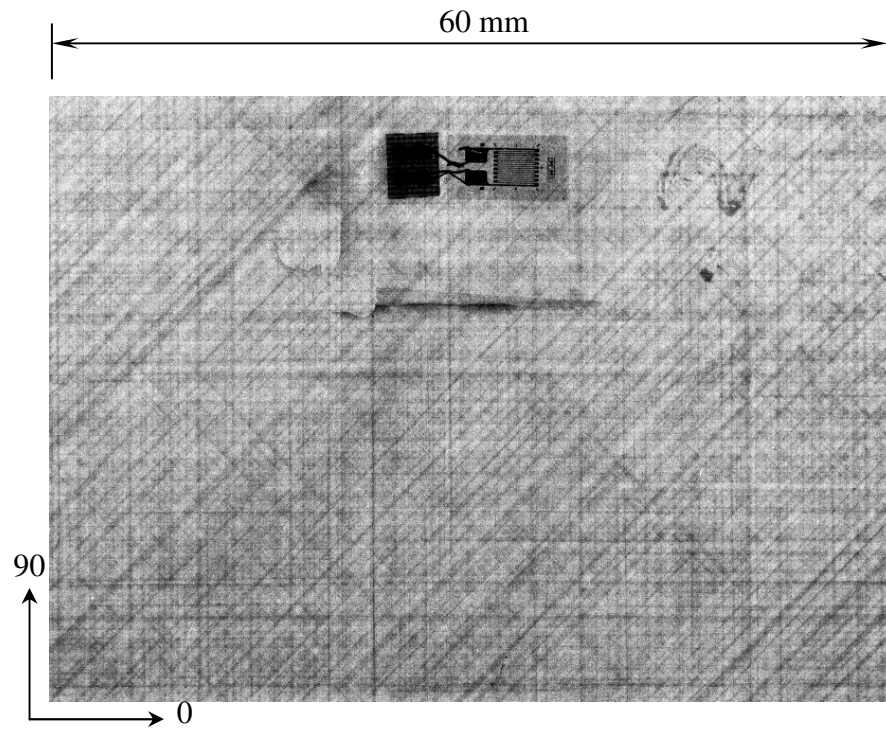
Fig. 2.32 X-ray image of a part of the TAMU-5 laminate.

X-radiography results for the 18-ply TAMU-5 specimen did not show any cracks and hence only the optical data was available for comparison. A penetrant enhanced X-ray image of the specimen is seen in Fig. 2.32. For this specimen, the comparison between the results obtained by using optical microscopy and ultrasonic polar backscattering technique are discussed in section 3.2 in Chapter III.

The results obtained by using X-radiography for the same area as shown in Fig. 3.12 have been presented earlier in Fig. 2.32. It is interesting to note that, X-radiography did not yield any information about the cracks in any of the four damaged plies. Also, from the schematics of the optically detected cracks in Figs. 3.12(c) and 3.12(d), it is clear that optical microscopy could detect only a small number of cracks visible at one of

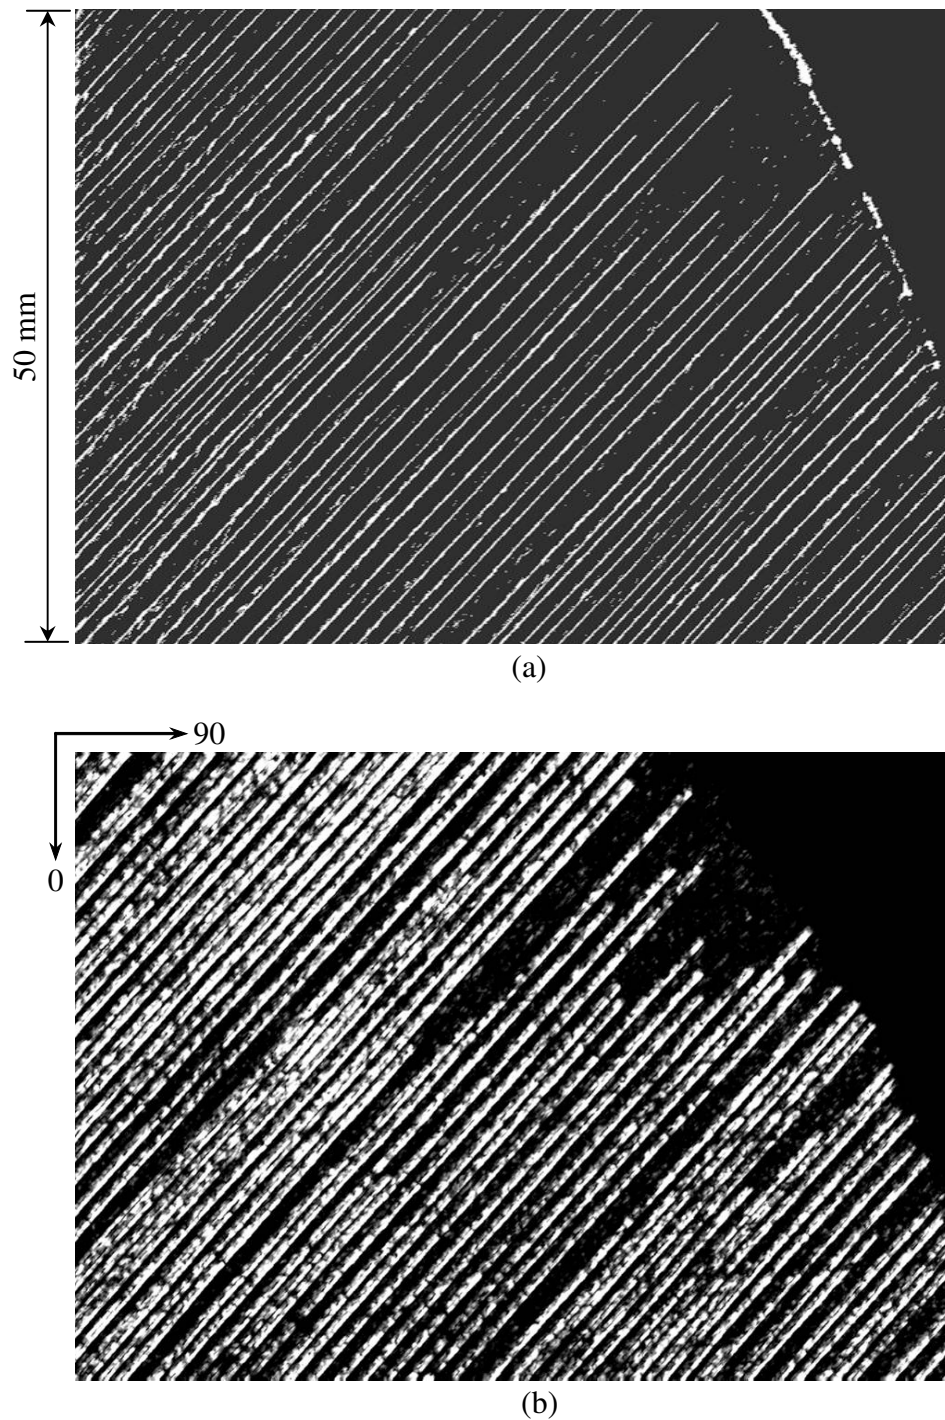
Fig. 2.33 (a) Filtered X-ray image, and (b) ultrasonic image, of cracks in the -45_2 ply-group of the TAMU-1 specimen. (The unfiltered X-ray image of the corresponding area can be seen in Fig. 2.27.)

Next, for ease of comparison with the ultrasonic data, the X-ray image of the TAMU-1 specimen, shown in Fig. 2.27, was filtered to remove all lines except those corresponding to -45_2 cracks using the standard Kaiser filter with a Hamming window (Details of the filter and the filtering process is beyond the scope of this thesis. Readers may refer to Matlab documentation for the same); the results are presented in Fig. 2.33(a). The ultrasonic image of the cracks in the -45_2 ply-group obtained by polar backscattering method is shown in Fig. 2.33(b). When the image in Fig. 2.33(a) was superimposed on the image of Fig. 2.33(b) on a computer screen, an excellent (virtually a one-to-one) correspondence was observed. The comparison was better than can be seen in the printed version because some information is inevitably lost in going from the computer screen image to the printed version. A similar comparison was made between the filtered X-ray images and the ultrasonic images of cracks in the -45_2 ply-group of the TAMU-2, TAMU-3 and the TAMU-4 specimens. The X-ray and the ultrasonic images of the TAMU-2 specimen are presented in Figs. 2.34(a) and 2.34(b) respectively; for the TAMU-3 specimen the corresponding images are shown in Figs. 2.35(a) and

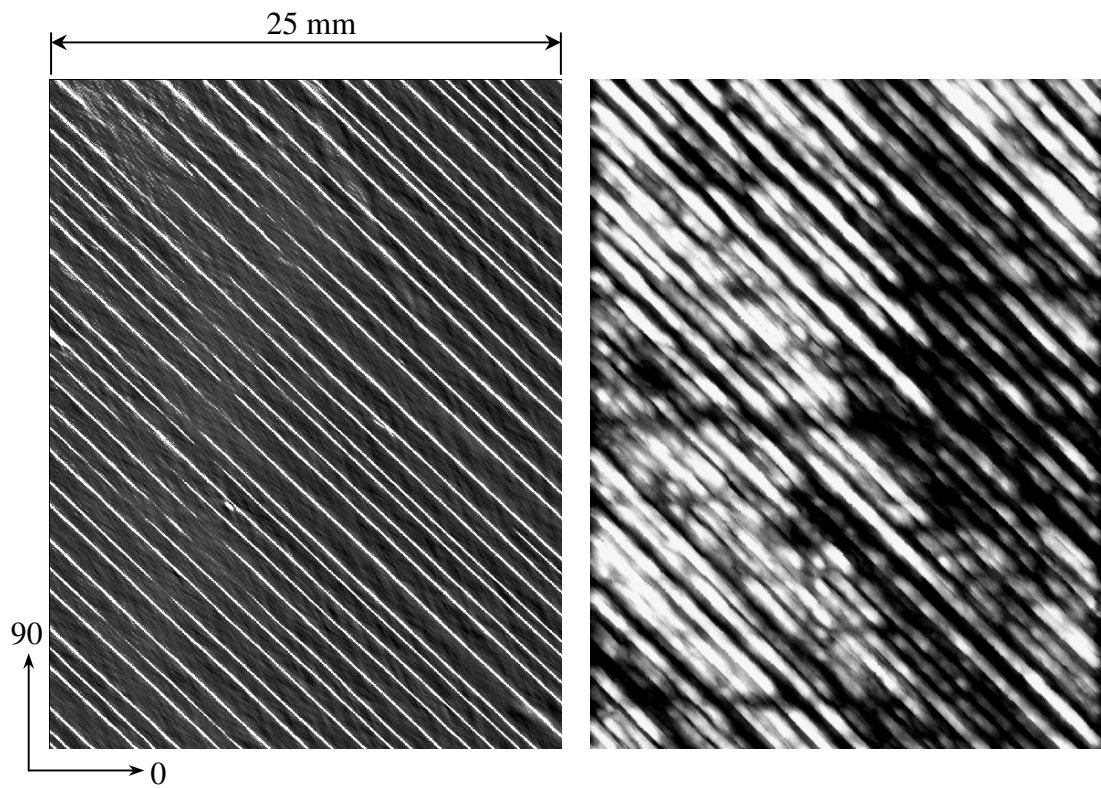
Fig. 2.34 (a) Filtered X-ray image, and (b) ultrasonic image, of cracks in the -45_2 ply-group of the TAMU-2 specimen.

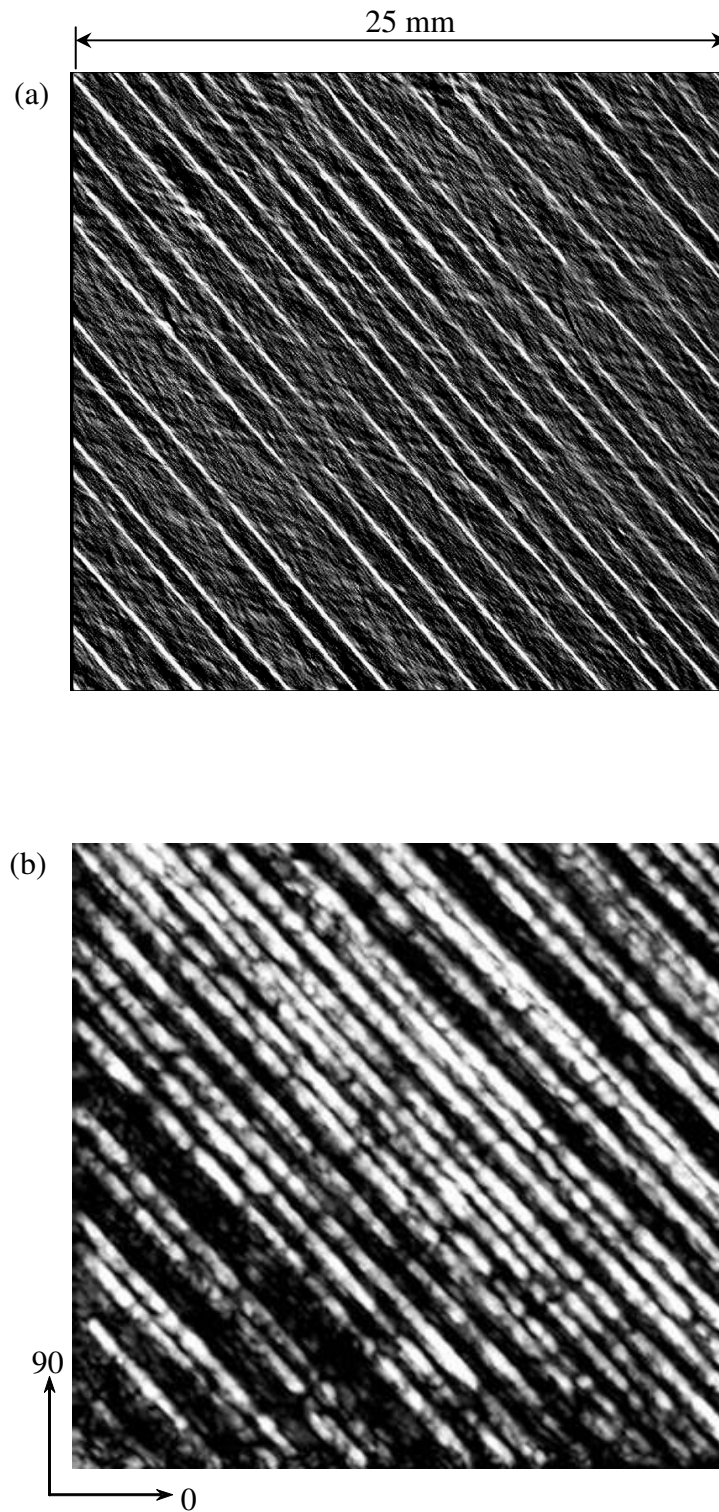
Fig. 2.35 (a) Filtered X-ray image, and (b) ultrasonic image, of cracks in the -45_2 ply-group of the TAMU-3 specimen.

2.35(b) and in Figs. 2.36(a) and 2.36(b) for the TAMU-4 specimen. In all the cases an excellent correlation was observed filtered X-ray and the ultrasonic images. Comparison for TAMU-5 specimen is not shown for reasons discussed earlier.

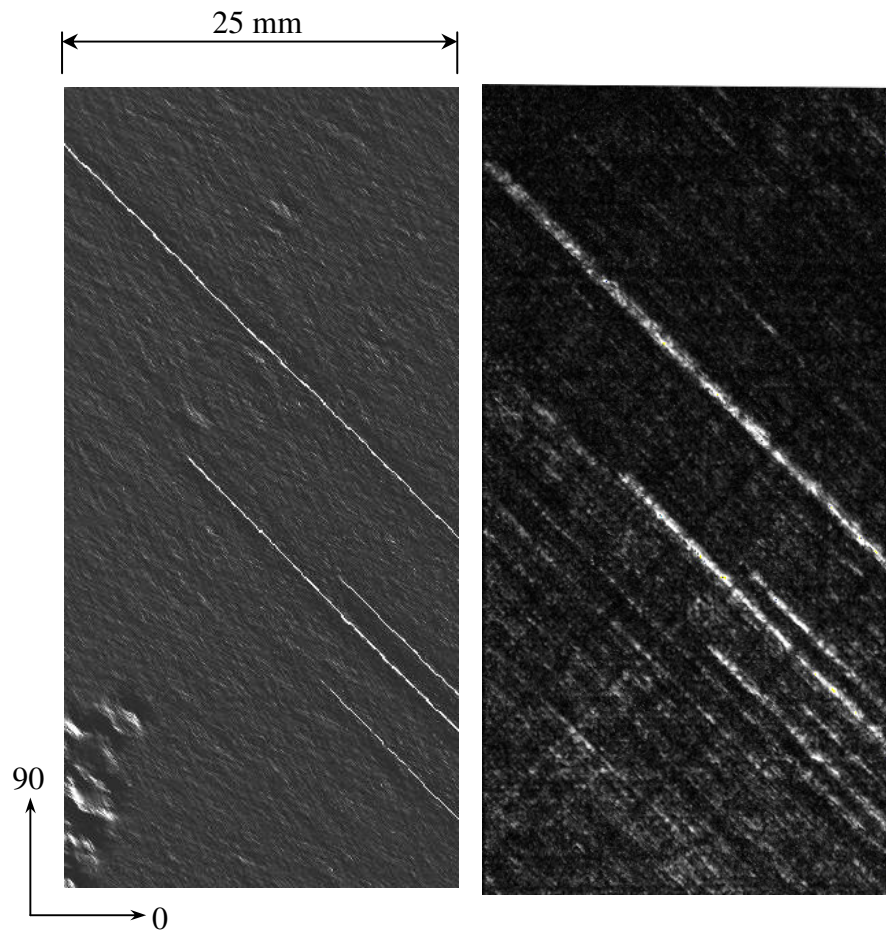
Fig. 2.36 (a) Filtered X-ray image, and (b) ultrasonic image, of cracks in the -45_2 ply-group of the TAMU-4 specimen.

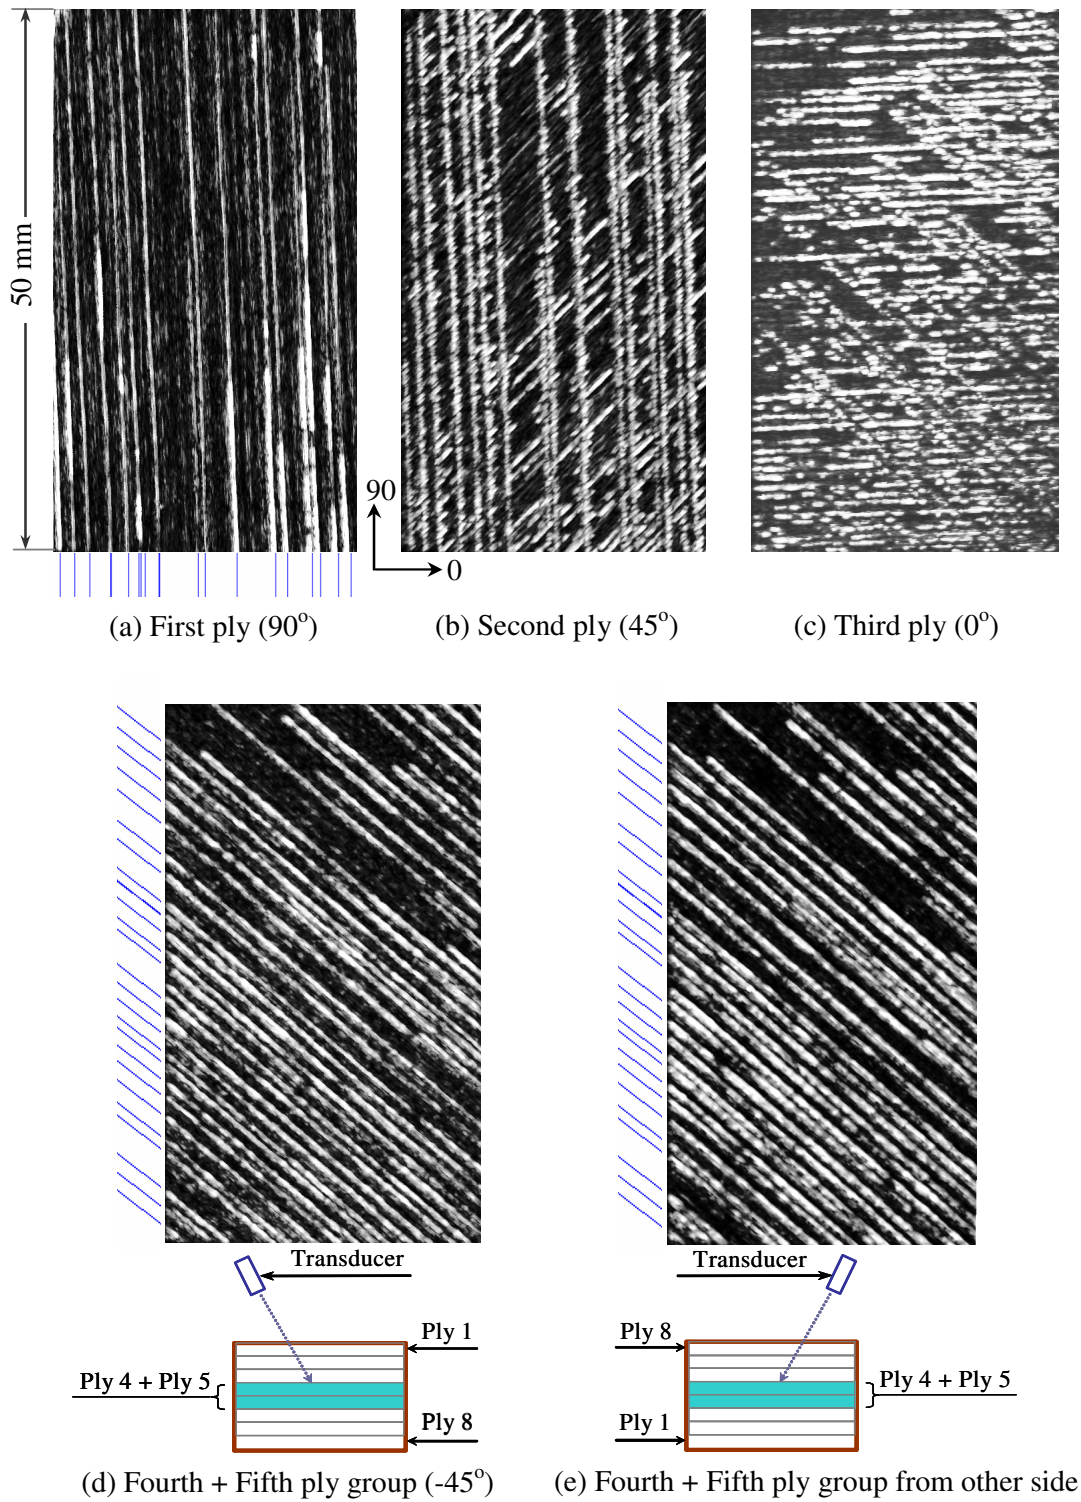
Fig. 3.1 Ultrasonic images of cracks in the eight plies of the $[90/45/0/-45]_s$ TAMU-1 specimen. (Angle of incidence = 25°)

The images of cracks in the TAMU-1 specimen were obtained by scanning it with a 20 MHz transducer oriented at 25° angle of incidence. The results for this highly damaged specimen are presented in Fig. 3.1(a) through (h) for cracks in the first through eighth ply, respectively. Schematic maps of the *optically detected* matrix cracks in a given ply are placed below Fig. 3.1(a) and Fig. 3.1(h) and to the left hand side of Fig. 3.1(d) and Fig. 3.1(e). For these cases, the ultrasonic images show excellent (almost one-to-one) correlation with the optical data. A large number of cracks were detected optically at the edges for the second, third, sixth and the seventh plies each. However, for reasons that will become clear in the following the optical data was not plotted alongside the respective plies in Fig. 3.1.

It is well known that, under practical loading conditions, the matrix cracks almost always run along the fiber direction. Accordingly, in the second ply we expect the cracks to run in the 45° direction. To a casual observer the cracks in Fig. 3.1(b) might appear to be running in the 90° direction. This is merely an illusion, and it may be explained as follows. A magnified image of the lower half of the second ply (as seen in Fig. 3.1(b)) is shown in Fig. 3.3(a). In the middle of the picture, one can clearly see cracks which originate at an interior point of the ply, run a *short* distance in the 45° direction, and

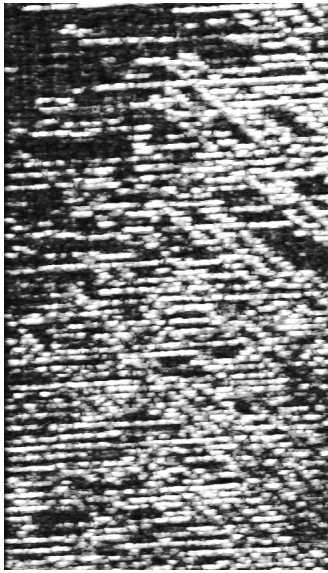
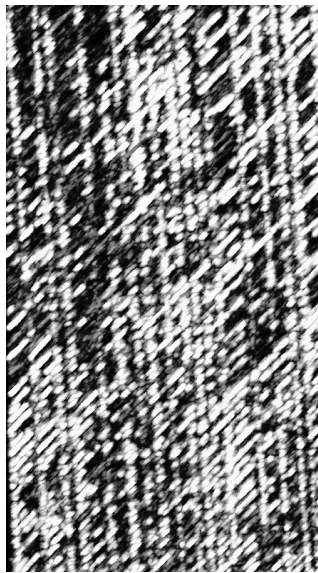
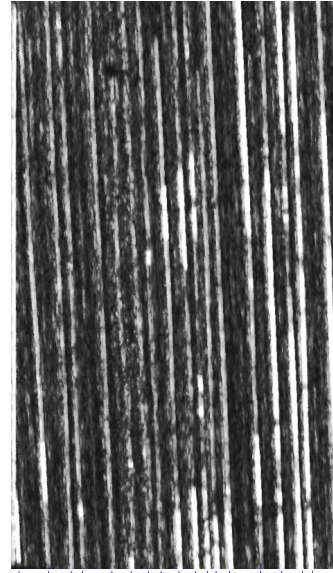
Fig. 3.1 (continued)

(f) Sixth ply (0°)

(g) Seventh ply (45°)

(h) Eighth ply (90°)

Evidently, in order to detect the cracks in the second ply the acoustic beam has to twice travel through the cracks in the first ply; to detect the cracks in the third ply the acoustic beam has to twice travel through the cracks in the first and the second ply; and so on. Clearly, the task of detecting cracks in a given ply becomes progressively more difficult as its depth increases. Of course this difficulty level depends upon the cumulative damage in the plies leading up to the ply being interrogated.

schematics of the optically detected cracks at the edges of the second, third, sixth and the seventh plies in Fig. 3.1.

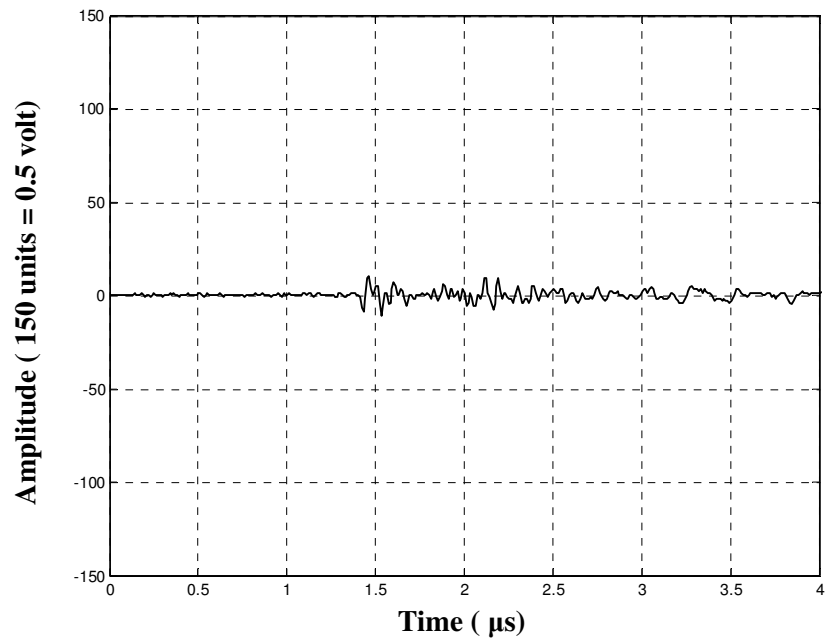
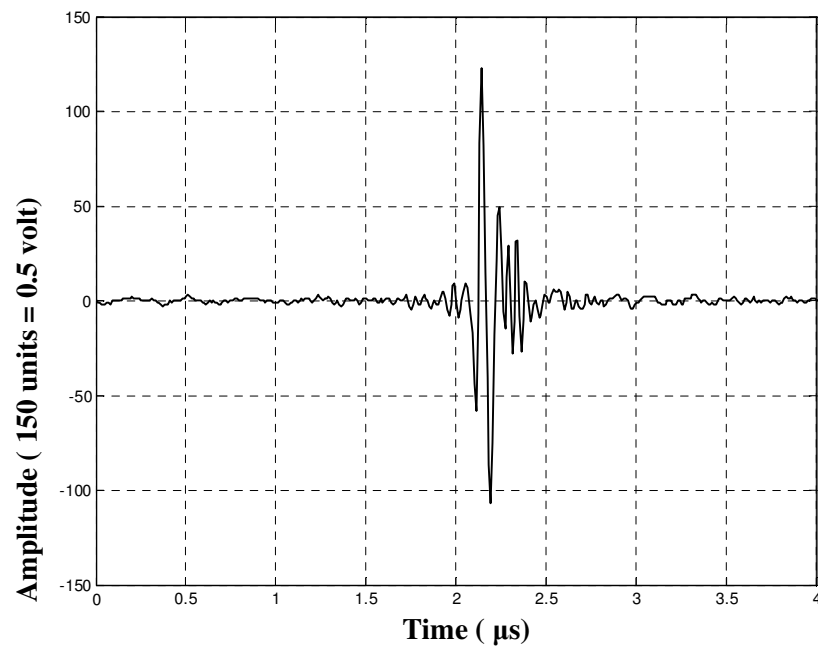
(a)

(b)

Fig. 3.2 Typical time domain signals; (a) in the absence of crack, (b) when a crack is insonified by the incident acoustic beam. (TAMU-1 specimen)

For this specimen, a typical time-domain signal in the absence of crack is shown in Fig. 3.2(a), while the time-domain signal in the presence of a crack is shown in Fig. 3.2(b). For both Figs 3.2(a) and 3.2(b) the transducer was oriented in such a way as to detect the cracks in the first ply (90°). The signal to noise ratio was found to be around 22 dB, indicating a high degree of confidence in the detection of the cracks.

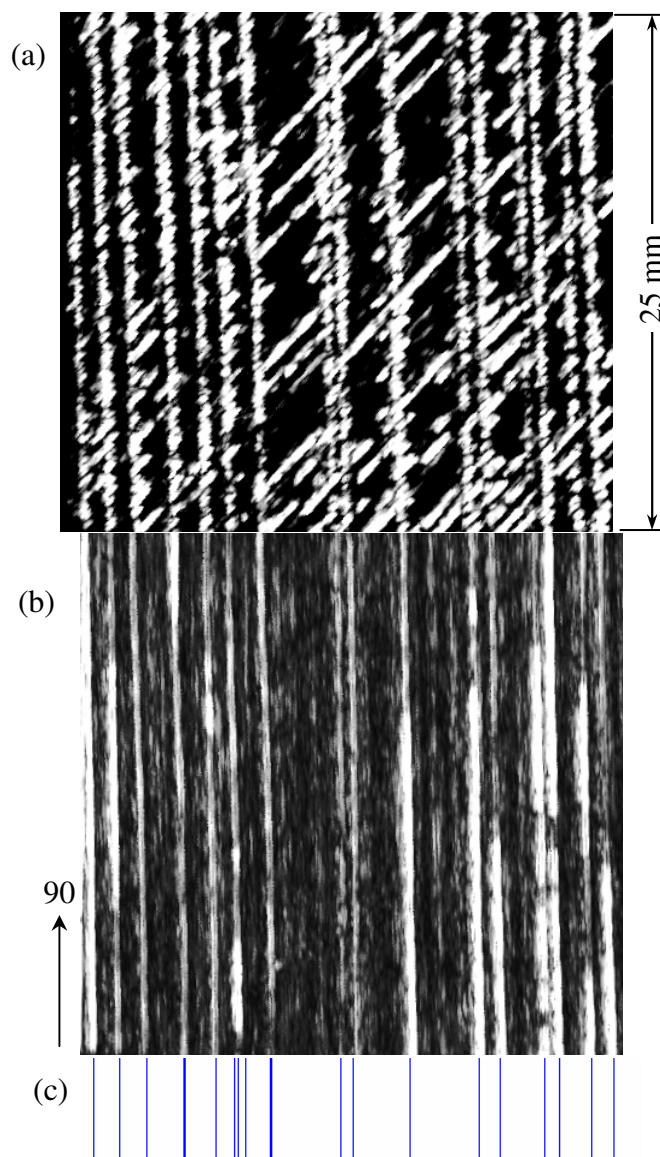
Fig. 3.3 (a) Short cracks in second ply (45°) of the TAMU-1 specimen, driven by cracks in the first ply (90°), (b) corresponding driving cracks in the first ply, (c) schematic of the optically detected cracks in the first ply.

come to a stop. One can see the same phenomenon throughout Fig. 3.3(a). It is interesting to note that the cracks are *not* distributed in a random manner. Instead, they are stacked (or aligned) in the 90° direction. Jamison et al. [31], Highsmith et al. [32], and more recently Lavoie and Adolfsson [33], have shown that these cracks owe their existence to the long (fully developed) cracks in the neighboring ply or ply-group (Lavoie and Adolfsson [33] call the neighboring plies as constraint plies and the short cracks in these plies as “stitch cracks” due to their characteristic appearance). In the present case, the short cracks in the second ply (45°) are produced by the long cracks in the first ply (90°).

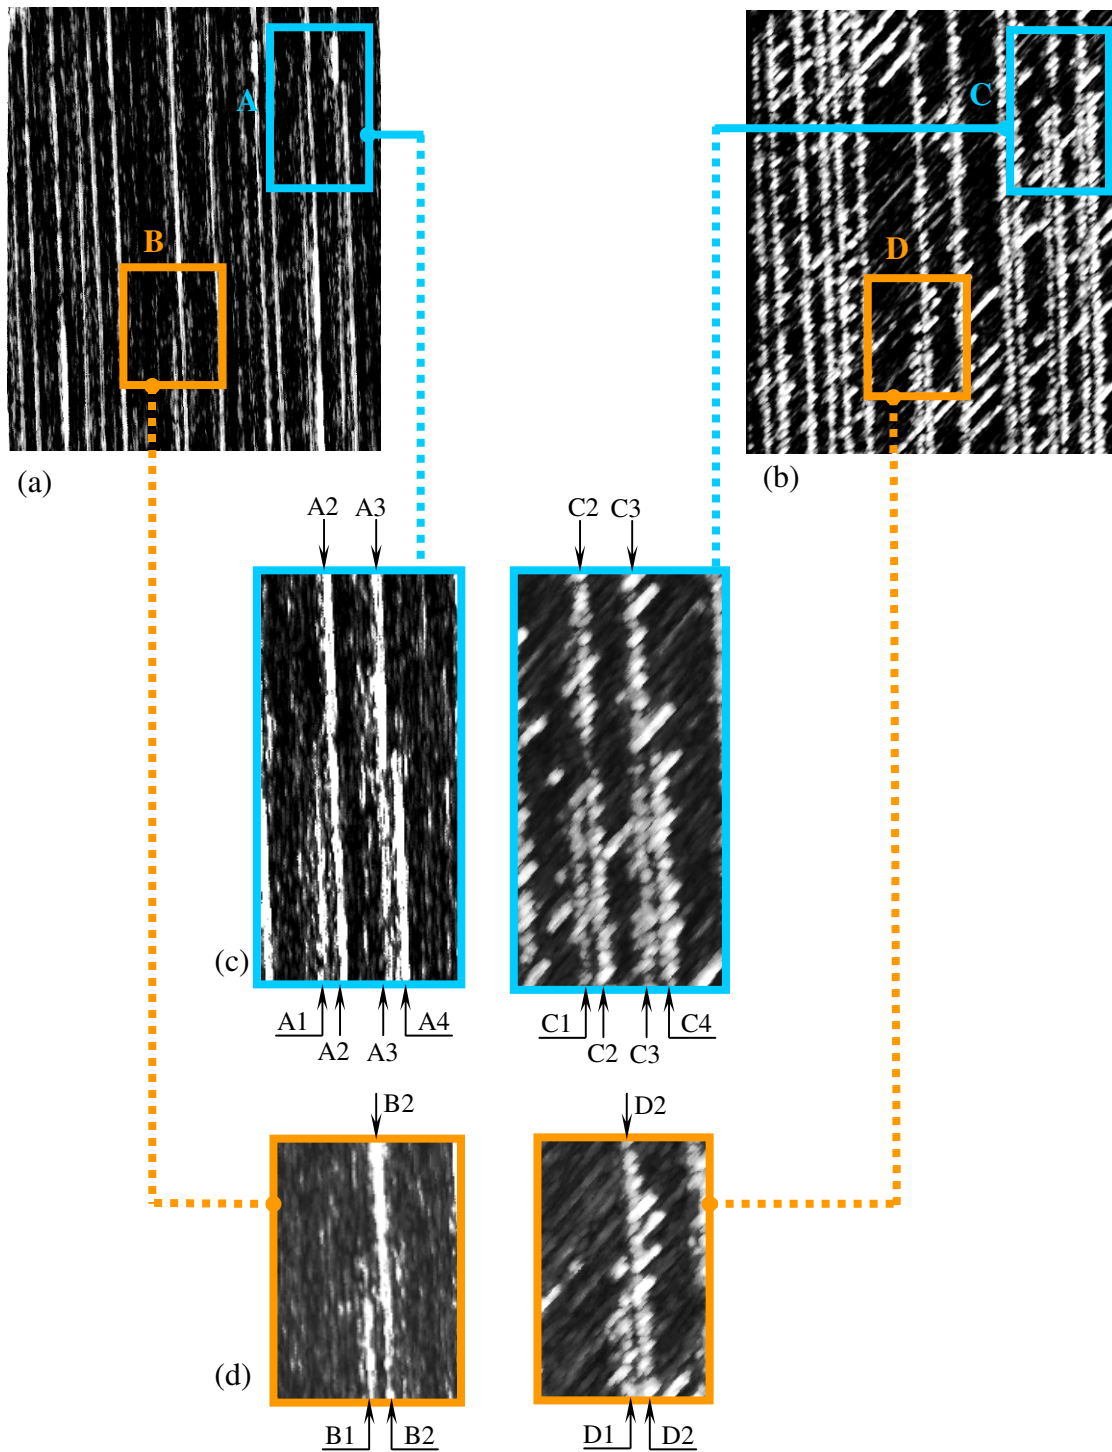
Fig. 3.4 (a) Cracks in first ply (90°), (b) short cracks in the corresponding area in the second ply (45°), (c) enlarged views of the areas marked A and C, (d) enlarged views of the areas marked B and D.

With either of the above explanations, it follows that there should be a strong correlation between the spatial location of the 90° long cracks in the first ply and the spatial location of the 45° short cracks in the second ply. It is satisfying to note that such a correlation indeed exists, as may be seen when the lower (corresponding) half of Fig. 3.1(a), reproduced in Fig. 3.3(b), is compared with Fig. 3.3(a). A schematic of the optically detected cracks in the first ply is shown in Fig. 3.3(c). The correlation is even more conspicuous if one observes the partial cracks in the first ply and the corresponding short cracks in the second ply. This is illustrated in Fig. 3.4. For the ease of presentation, the upper halves of Figs. 3.1(a) and 3.1(b) showing cracks in the first and the second plies are reproduced in Figs. 3.4(a) and 3.4(b) respectively. Partial cracks in the first ply are contained in areas marked by rectangles A and B (Fig. 3.4(a)). Corresponding areas in the second ply containing short cracks are marked by rectangles C and D respectively (Fig. 3.4(b)). Enlarged views of the cracks in the area A (first ply) and the corresponding short cracks in the area C (second ply) are presented in Fig. 3.4(c). Similarly, cracks in corresponding areas B (first ply) and D (second ply) are shown in 3.4(d). In Fig. 3.4(c), the cracks in the first ply marked A1 and A4 are partial cracks

terminating around the central area of the rectangle, whereas, cracks marked A2 and A3 extend throughout the length of the rectangle. In the second ply, corresponding to the cracks A1, A2, A3 and A4, four columns of short cracks are marked as C1, C2, C3 and C4 respectively. It is seen that, the short cracks in the columns C2 and C3 (caused due to the cracks A2 and A3 respectively) extend over the entire length of the rectangle while the short cracks in columns C1 and C4 (caused due to the cracks A1 and A4 respectively) exist only as long as the partial cracks A2 and A3 exist in the first ply. A similar phenomenon is observed in Fig. 3.4(d), where the cracks marked B1 and B2 in the first ply give rise to columns of short cracks marked D1 and D2 respectively in the second ply. This experimental data provides overwhelming evidence in support of the fact that the short cracks are caused by the fully developed cracks in the adjacent plies.

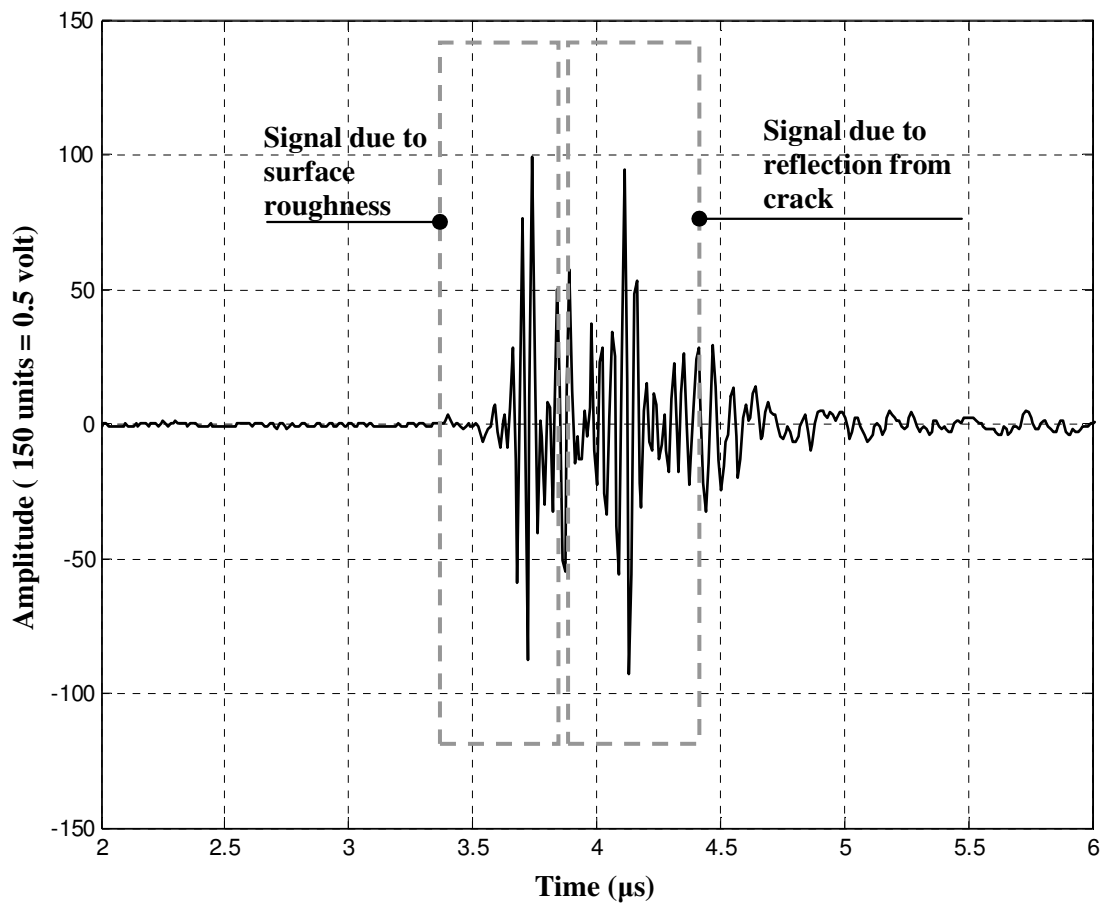
Fig. 3.5 Typical time-domain signal for the TAMU-4 specimen when the incident ultrasonic beam insonifies a crack through a rough surface.

When the specimens were scanned for cracks from the rough side, proper gating of the time-domain signal was required to separate the signals reflected by the cracks from the backscattered signal due to surface roughness. As an example a time-domain signal for the TAMU-4 specimen is presented in Fig. 3.5. The transducer was oriented to detect cracks in the first ply through the rough surface. The backscattered signal due to the surface roughness was found to be present for an initial period of about 0.4 μ s. If a gate for collecting the data is improperly placed in such a way that it includes the signal due to the rough surface, the resulting image will show a large amount of noise making it difficult to discern cracks from the artifacts due to surface roughness. To demonstrate this, three gates of different length were set on the time domain signal as shown in Fig. 3.6(a). Gate A spans the entire time-domain signal and the corresponding image obtained is shown in Fig. 3.6(b). The length of the Gate B was set to 400 ns and was placed in such a way that it spans the entire signal due to the surface roughness gathers.

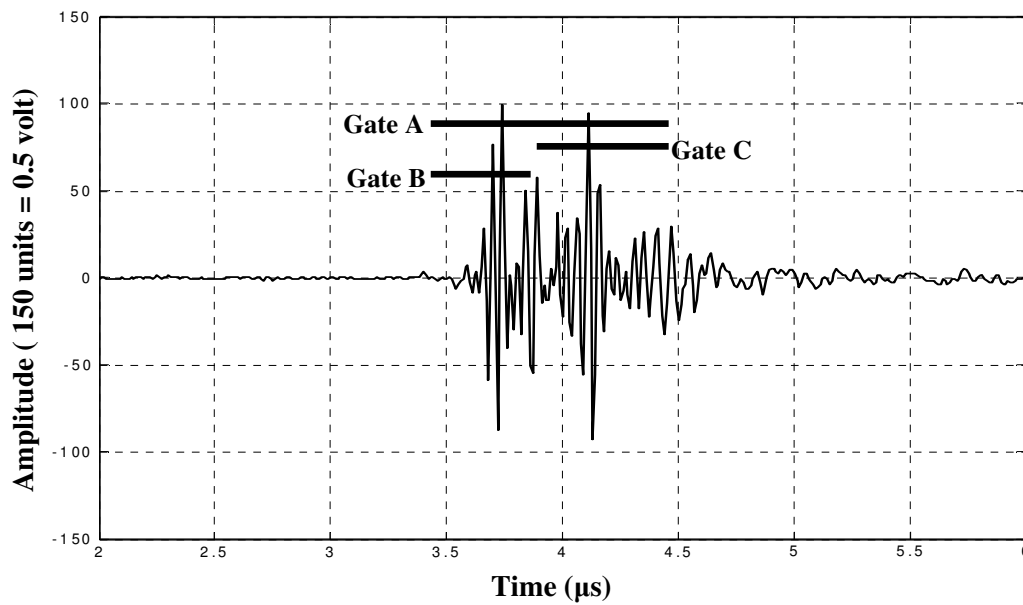
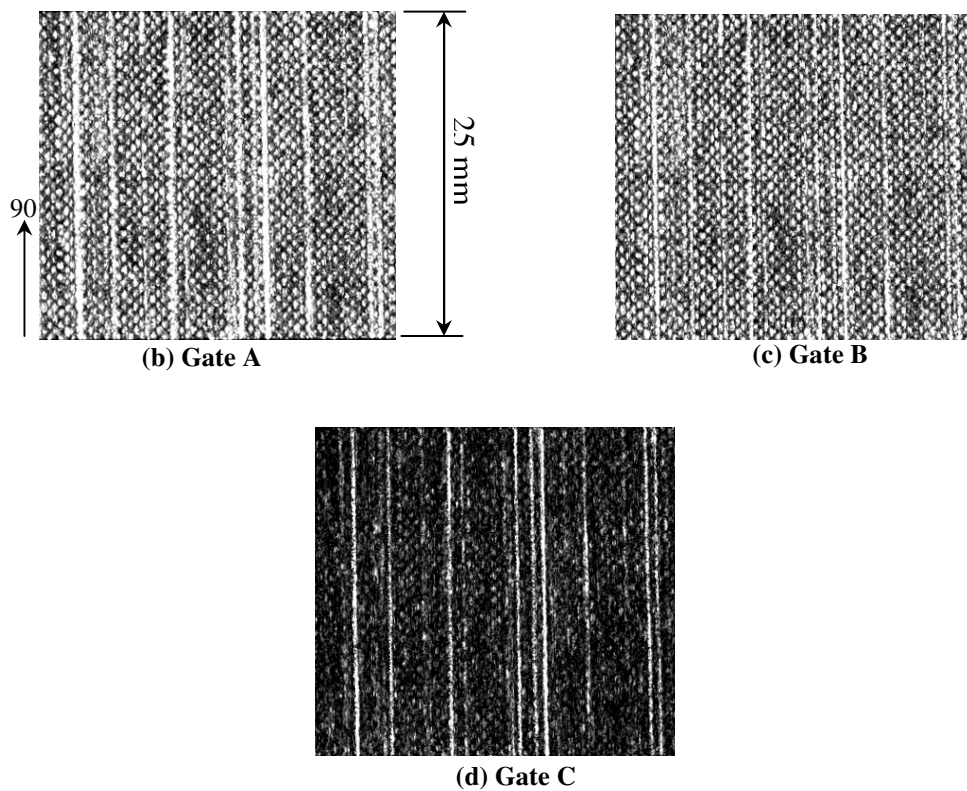
(a) Time domain signal, obtained when the interrogating acoustic beam insonifies a crack through the rough surface, showing position of gates A, B and C

Fig. 3.6 Effect of gate positioning on image of cracks in the first ply of the TAMU-4 specimen.

The image obtained by using this gate is shown in Fig. 3.6(c). Gate C is adjusted in such a way as to exclude most of the signal due to surface roughness. The resulting image is seen in Fig. 3.6(d). Cracks are observed only in the image corresponding to Gate C.

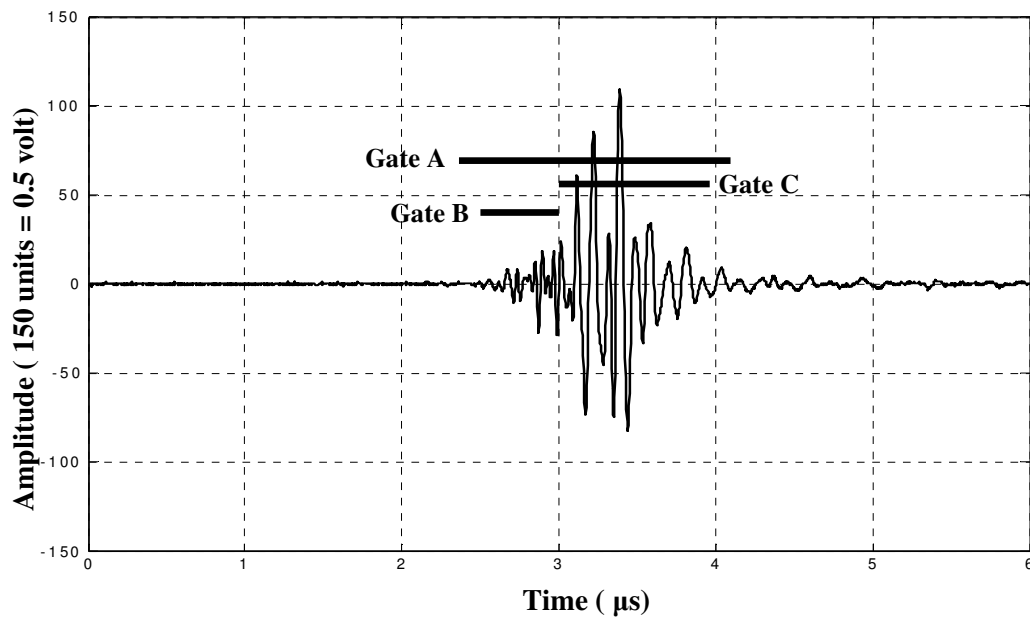
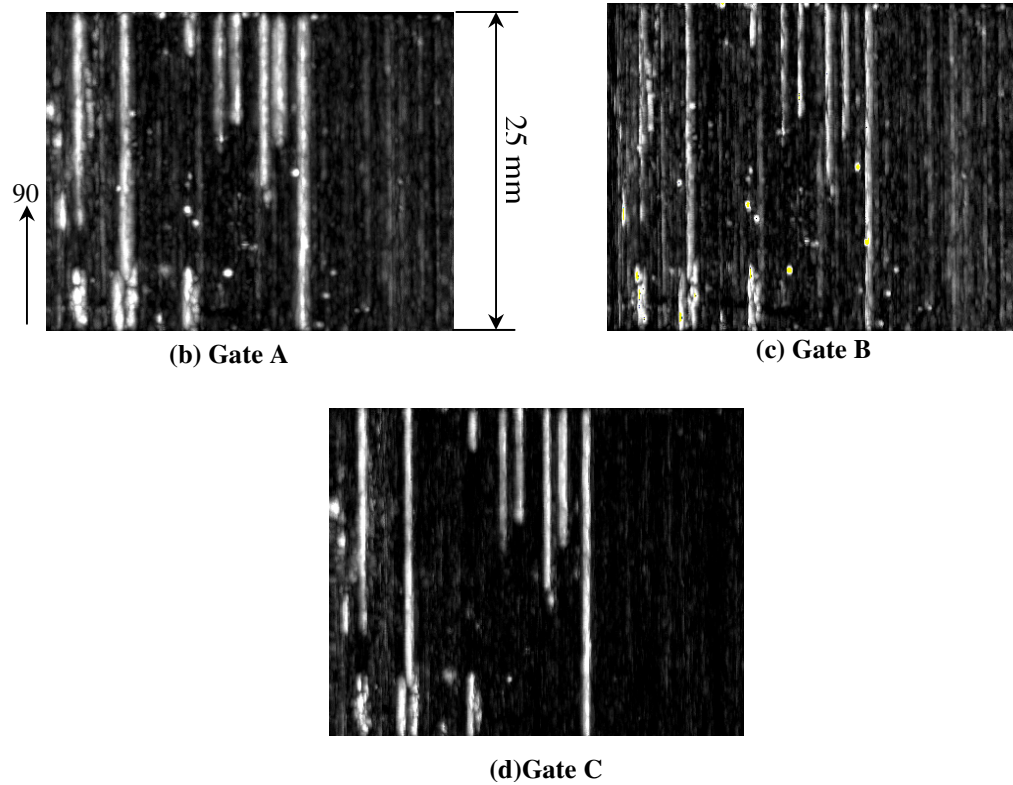
(a) Time domain signal, obtained when the interrogating acoustic beam insonifies a crack through the aluminum liner, showing position of gates A, B and C

Fig. 3.7 Effect of gate positioning on image of cracks in the first ply (ply adjacent to the aluminum liner) of the TAMU-2 specimen.

For the TAMU-2 and the TAMU-3 specimens it was observed that the presence of liners did not significantly alter the nature of the received signal during the ply-by-ply detection of cracks through the liners. The angle of incidence and the height of the transducer above the specimen were maintained the same as in the earlier case when the specimens were scanned for cracks through the rough side. For the TAMU-2 specimen, a typical time domain signal received in the presence of a crack in the ply adjacent to the aluminum liner while scanning through the liner, is shown in Fig. 3.7(a). In this case, to gather data, three gates of different lengths and at different positions were used; namely, Gate A of 1.8 μ s duration covering the entire time domain signal, Gate B of 800 ns duration beginning approximately from the end of gate B. These gates are shown in Fig. 3.7(a). The resulting images using Gates A, B and C are presented in Fig. 3.7(b), Fig. 3.7(c) and Fig. 3.7(d) respectively. From these images, it is clear that the position of a gate over the time domain signal did not greatly influence the resulting images.

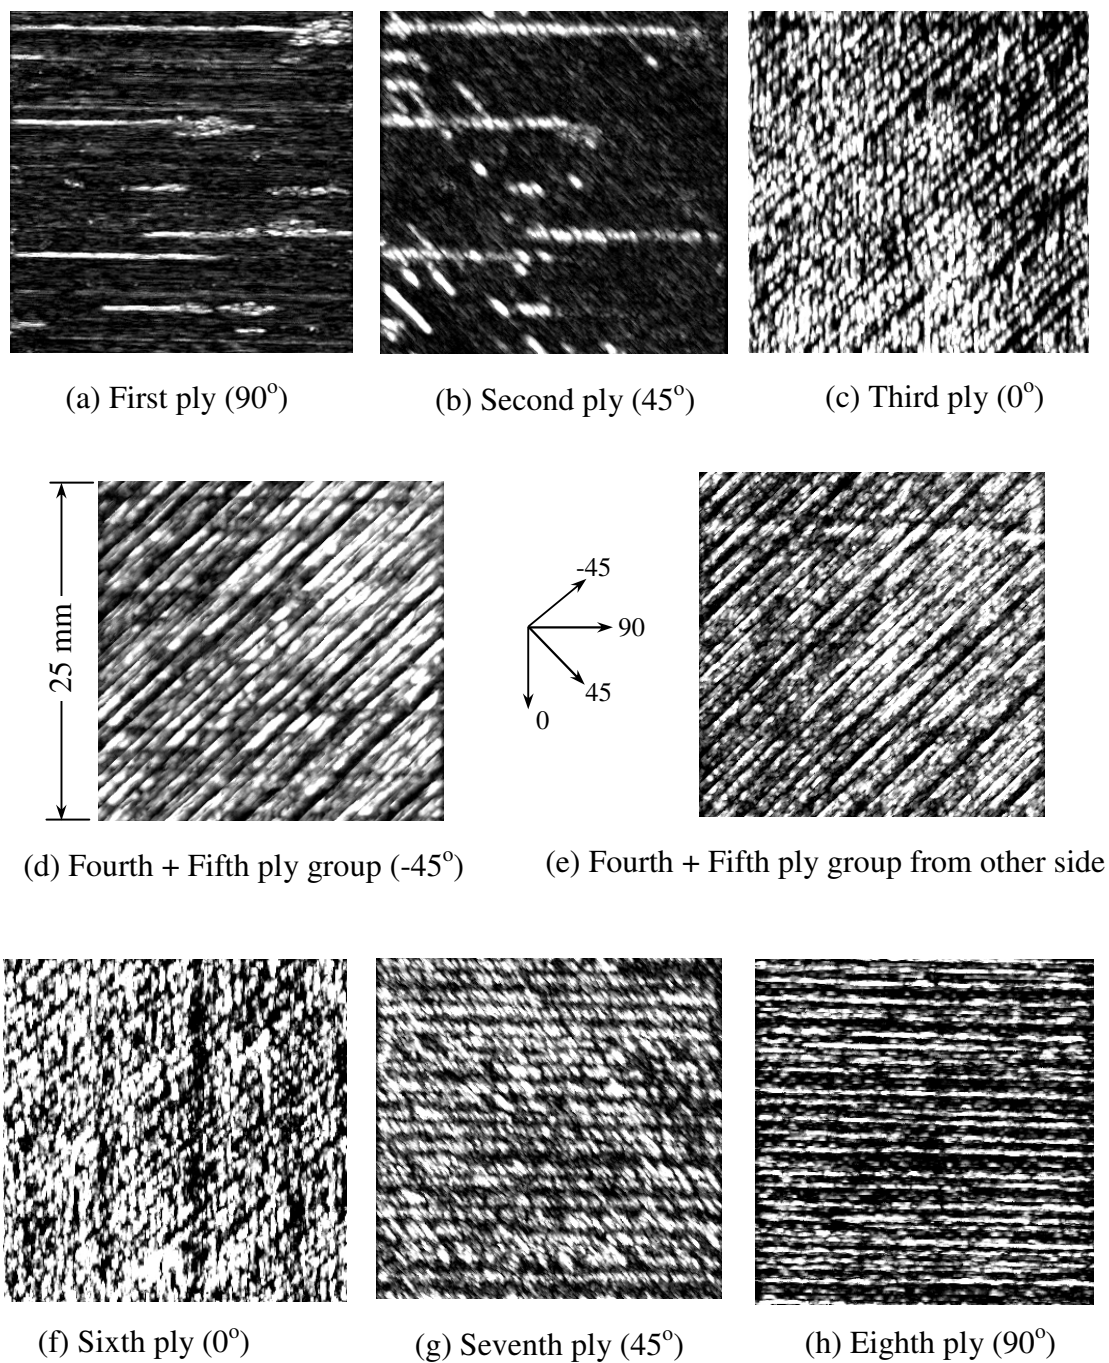
Fig. 3.8 Ultrasonic images of cracks in the eight plies of the $[90/45/0/-45]_s$ TAMU-2 specimen. (Angle of incidence = 25°)

Ply-by-ply ultrasonic NDE results for all the eight plies of the TAMU-2 and the TAMU-3 specimens are presented in Figs. 3.8(a) through (h) and Figs. 3.9(a) through (h) respectively. The liner is on the first ply for both the specimens. Figures 3.10 (a) through (h) show the cracks in all the eight plies of the TAMU-4 specimen. As done earlier in the case of TAMU-1 specimen, in the spirit of self-calibration, the cracks in the -45_2 ply-group of all the three specimens were detected using two different acoustic paths, one
